Failure Analysis of CCD Image Sensors using SQUID and GMR Magnetic Current Imaging

Frederick S. Felt

Failure Analysis Laboratory

NASA Goddard Space Flight Center

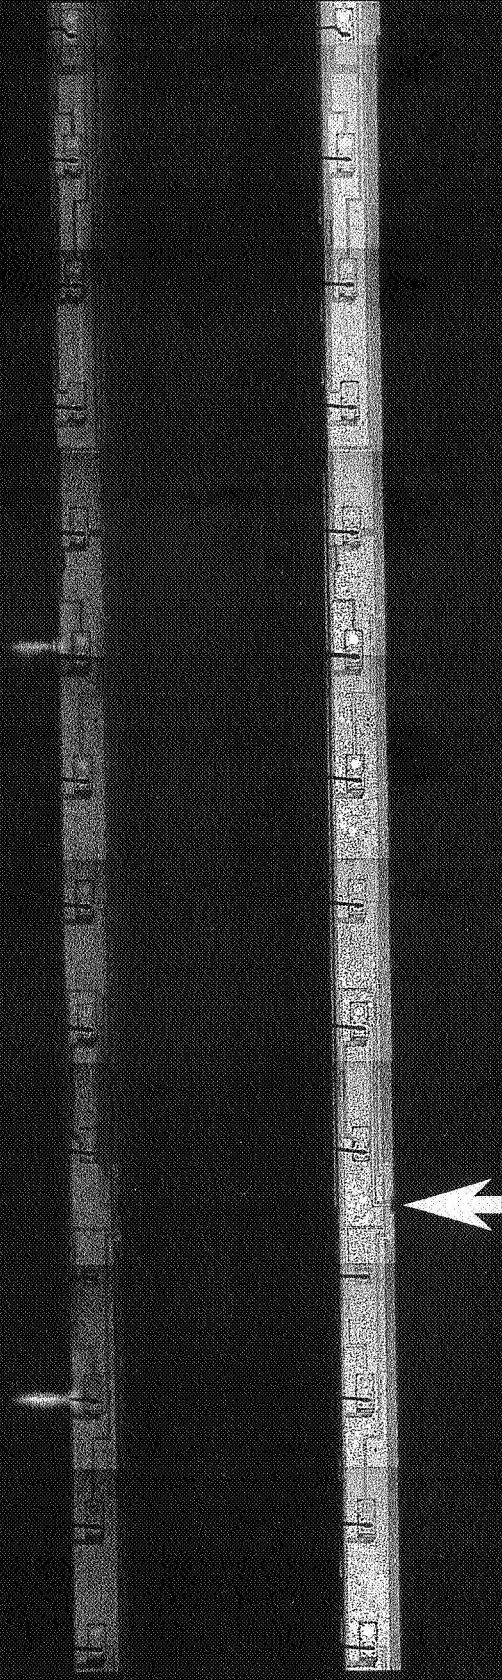
SQUID Current Map

- Overlay: current map and optical image
- Scan plane at 50 microns
- Ceramic package blocks scan at CCD corner

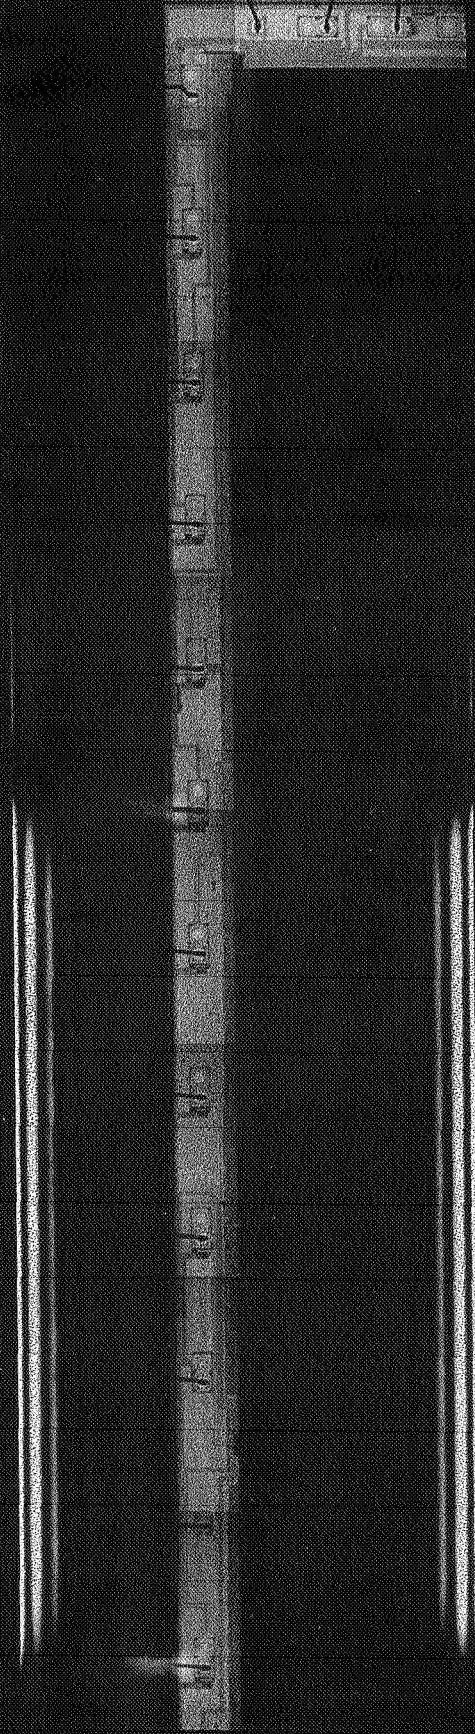
SQUID Current Map

- Scan plane increased to avoid ceramic package
- Resolution decreases
- Corner selected for GMR zoom

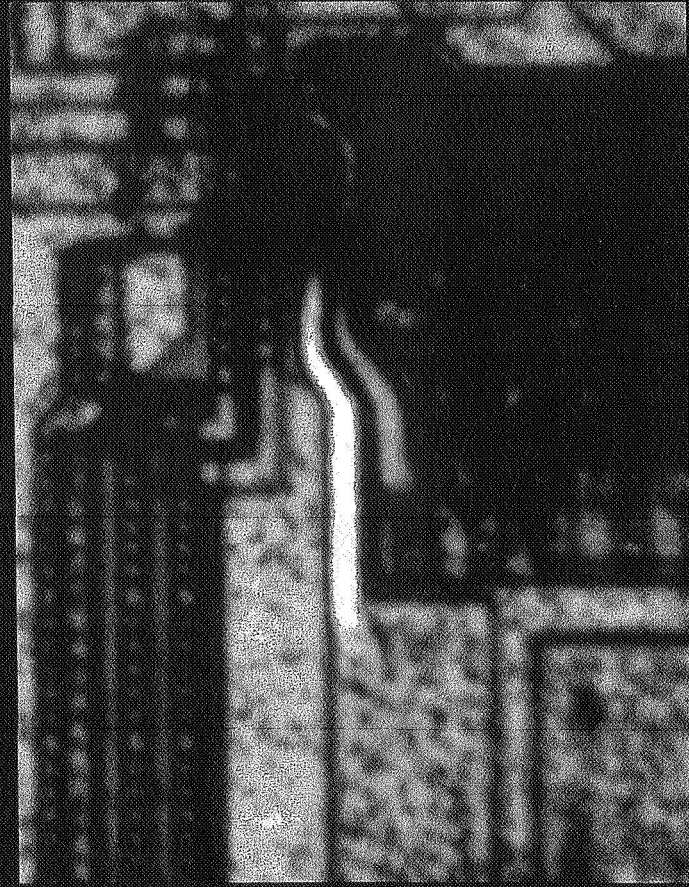
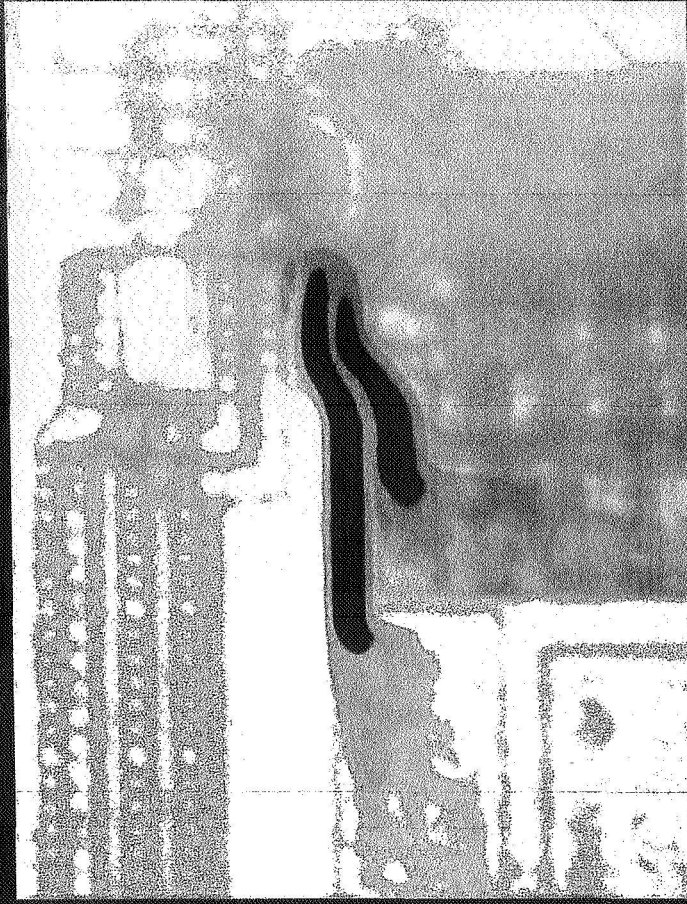
High-resolution GMR Scan

- Defect resolved to charge amplifier region with sub-micron resolution

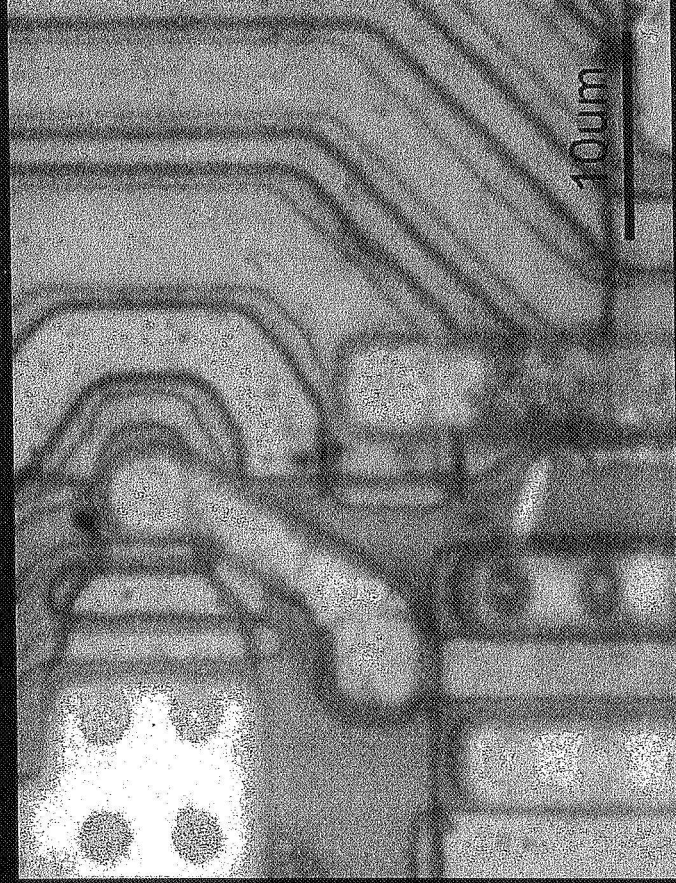
SN09

- Light shield removed by parallel polishing
- Optical inspection find anomalies

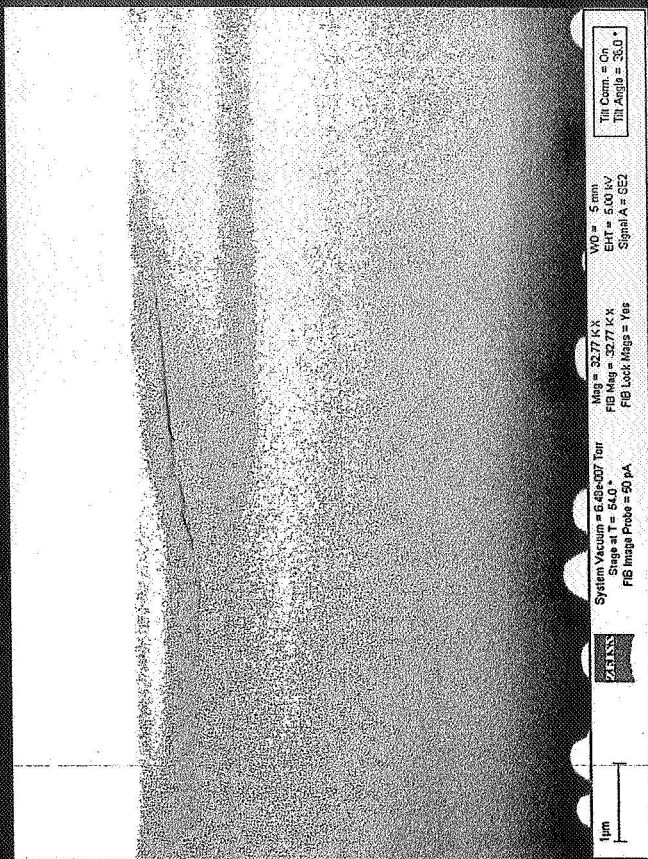
SWA/LA1 short L1

- SN06 FIB cross section
- Evidence of cracking, bridging

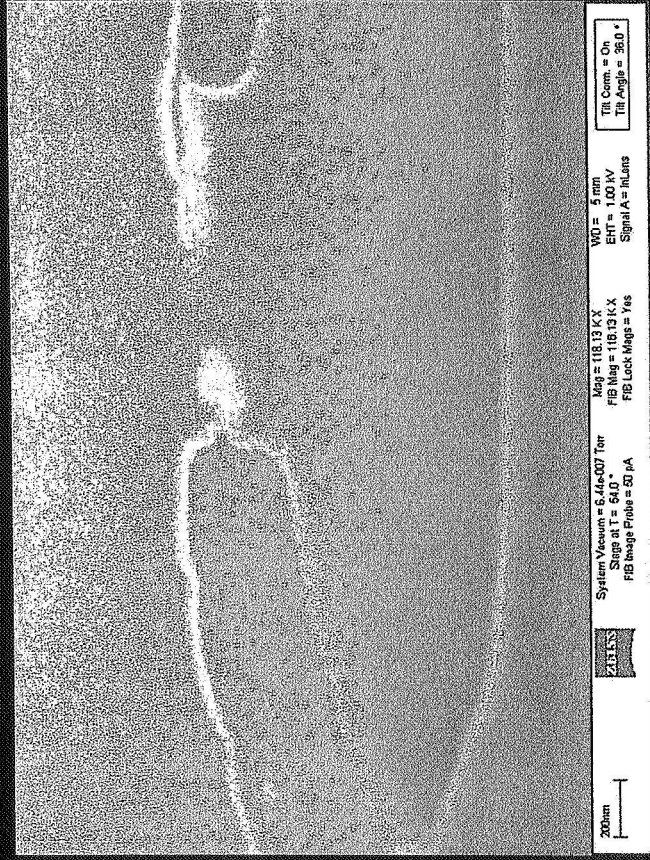
SWA/LA1 short L2

- SN06 FIB cross section
- Evidence of cracking, bridging

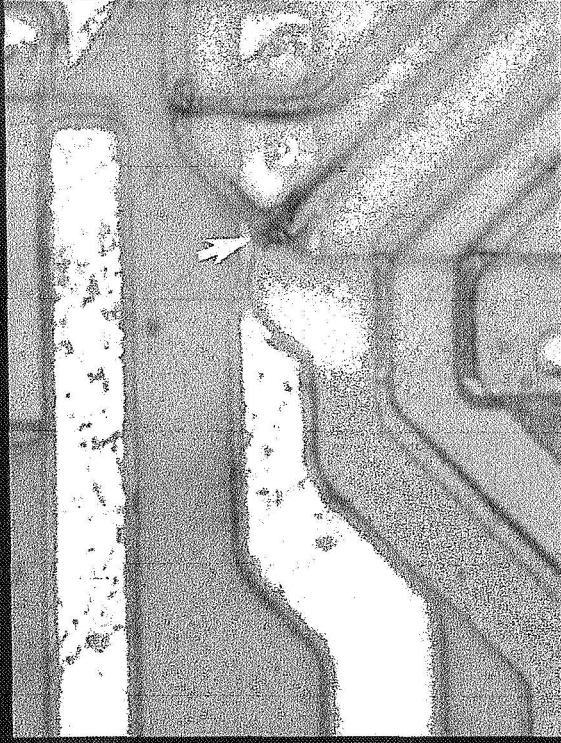
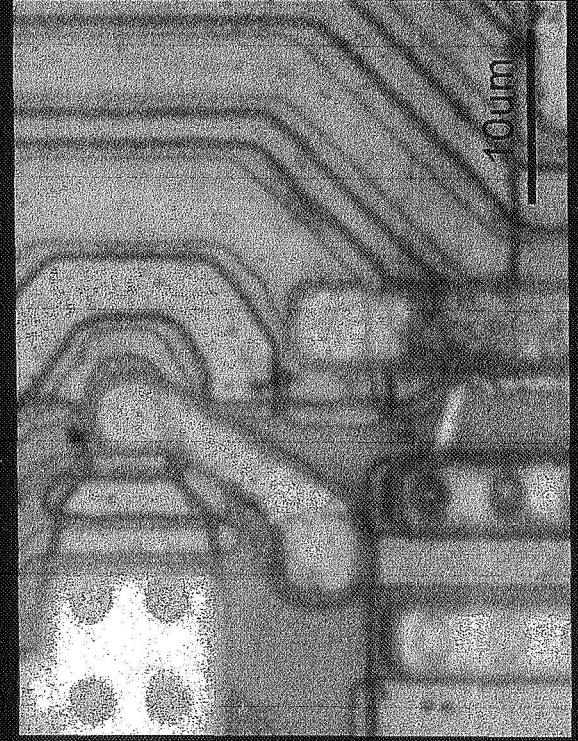
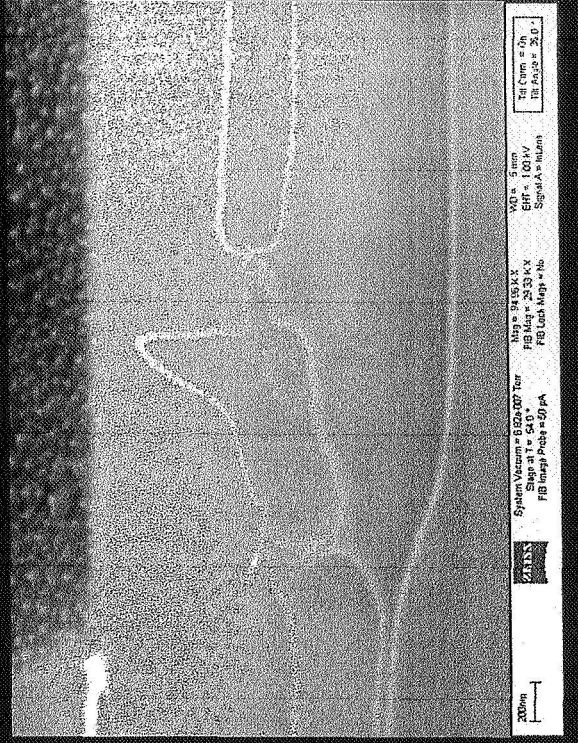
- ESD or line transient
- ..with possible secondary damage caused by IR testing

ESD protection technology and practices used at the test laboratory where these devices are being tested in the application mode is being reviewed to prevent ESD damage to a second set of CCD devices.
